# Manhole Inspection Summary

Manhole # S69M\_\_008MH

Insp Date: **2/5/08 11:51 AM**

**Location** Address: **6719 German Hill Rd.** Cross Street: **Bethlehem Ave.**

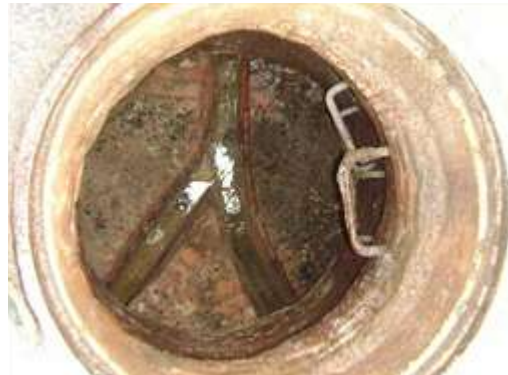
Top View

**Frame** Offset: **2** (in.) Condition: ☐ Sound ☒ **Cracked** ☒ **Leaks**

**Chimney / Frame Adjustment** ☒ Exists Material: **Brick and Concrete** ☐ Parged Height: **12** (in.)  
Condition: ☐ Sound ☐ Cracked ☐ Root Intrusion ☒ **Loose Brick** ☒ **Deteriorated**  
Infiltration: ☐ None ☒ **Joint** ☐ Cracks ☒ **Mortar** ☐ Roots ☐ Wall
